CSX Kanawha Trestle Inspection Report Charleston, West Virginia

Michael Baker Jr., Inc.

August, 2011

**UNDERWATER INSPECTION
OF
KANAWHA TRESTLE
KANAWHA RIVER PIERS
IN
CHARLESTON, WEST VIRGINIA**

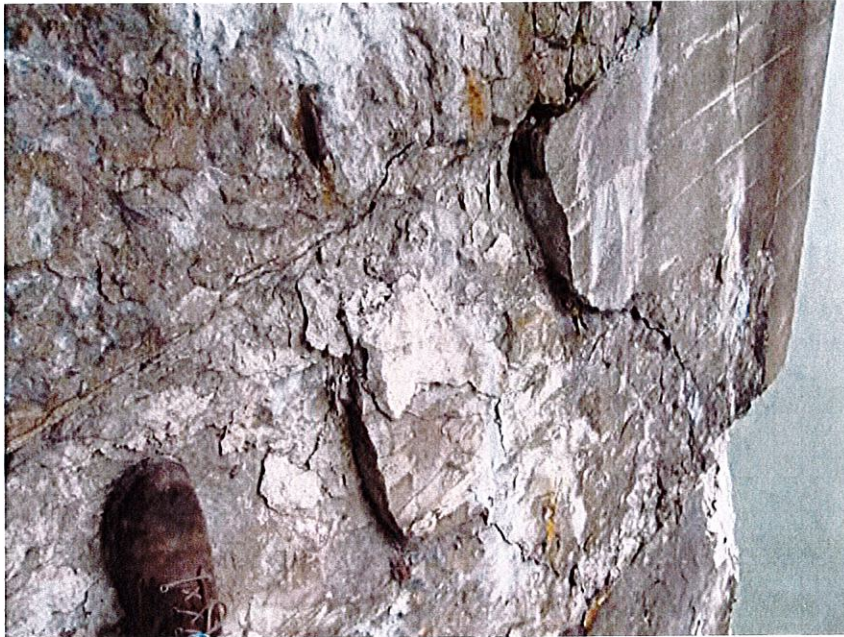
Photo No. 1 Pier 25, north face, downstream

Condition: Extensive deterioration with spalls up to 1 ft deep

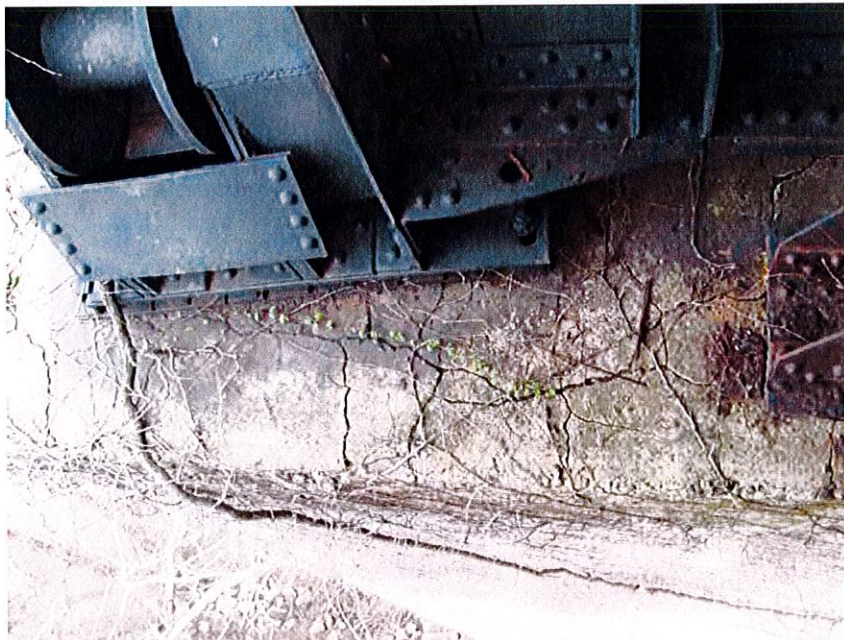
Photo No. 2 Pier 24, top of cap, downstream truss bearing

Condition: Severe map cracking adjacent to the truss bearing

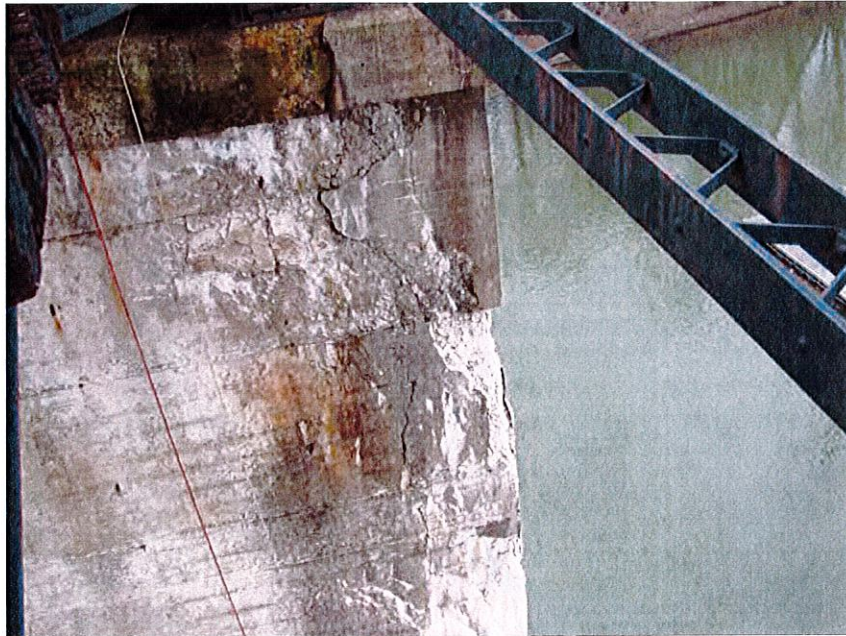
Photo No. 3 Pier 25, south face, downstream

Condition: Cracking, delamination, and spalling in the upper pier shaft

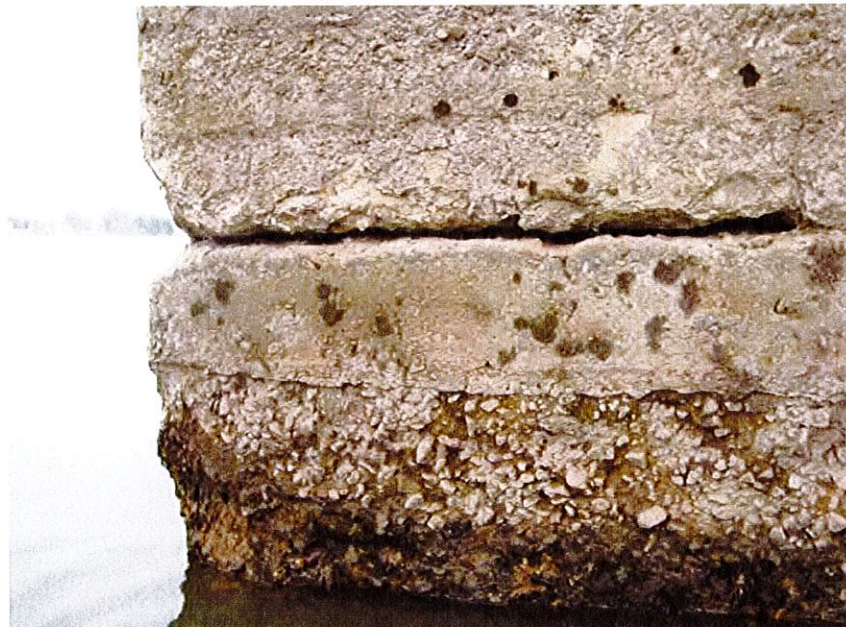
Photo No. 4 Pier 26, downstream, south face

Condition: Severe scaling and open construction joint with spalling at the waterline

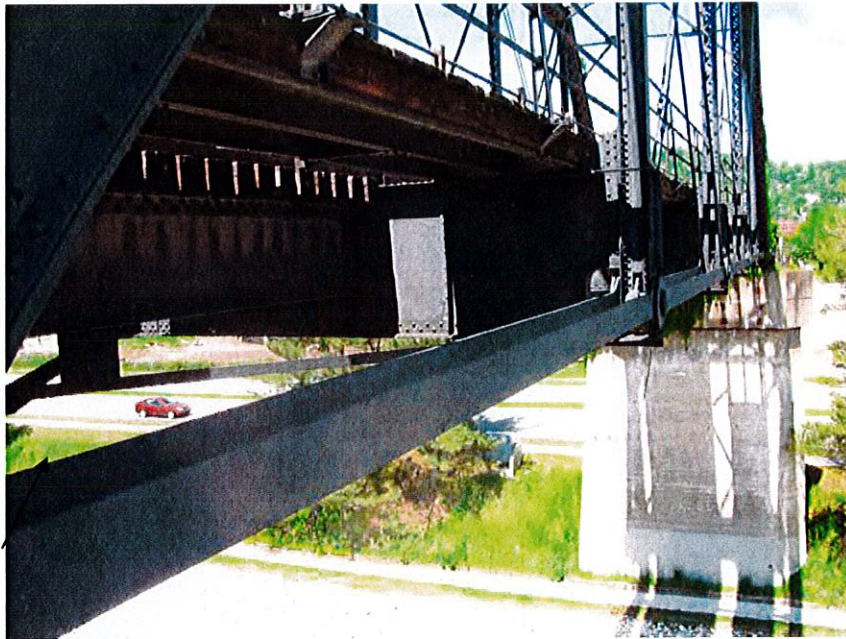
Photo No. 5 Bottom chord, truss span, Pier 27 to Pier 28
Condition: Typical view of the truss span

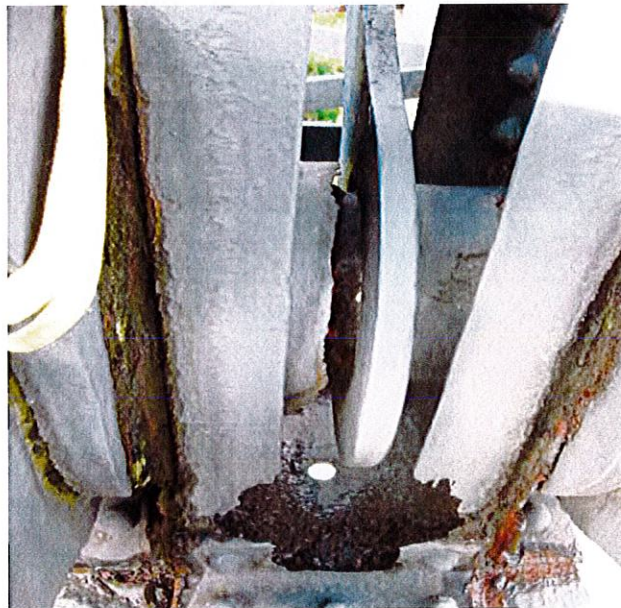
3. Significant rust packing and corrosion at all top and bottom truss chord connections was found (See Photos 5 to 8). The rust packing and corrosion has led to additional stress on the pins and section loss to the ends of the eye-bars of the truss members. The tightness of the rust packing and extent of the corrosion made it impossible to determine the remaining section. As part of the rehabilitation, we recommend blast cleaning the pin areas, re-inspecting the eyebars and ultrasonically test the pins. These areas also need to be repainted to prevent further deterioration. If the UT testing or the re-inspection reveals defects during construction, additional repairs may be required (Items 23 and 24 in the estimate).

Photo No. 6 L2, DS Truss Between P24 and P25
Condition: 1" Rust pack with significant section loss to truss members

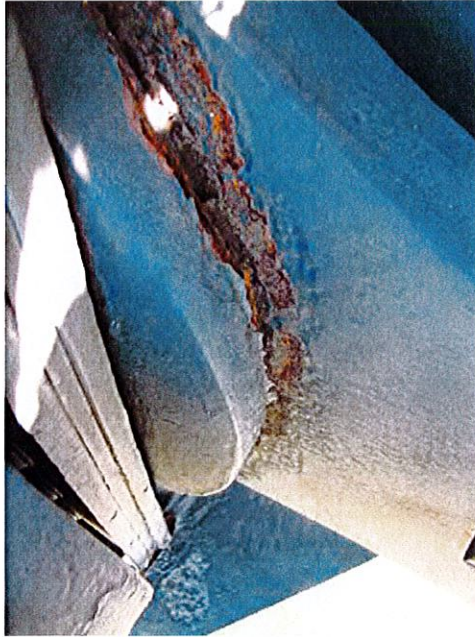
Photo No. 7 Main River Truss, L4', Downstream Truss

Condition: $\frac{1}{4}$ " section loss to the eyebars with $\frac{1}{2}$ " rust pack

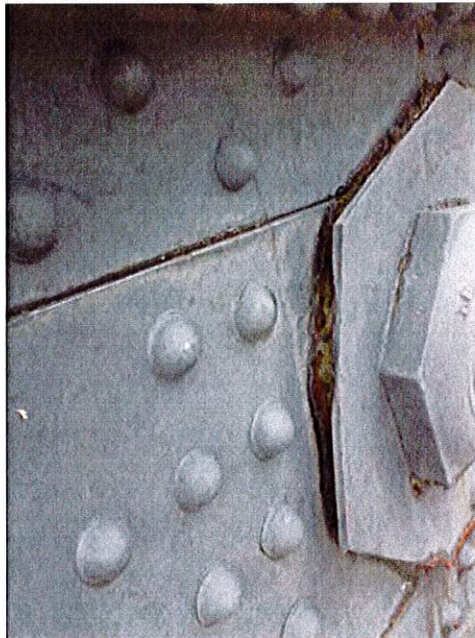
Photo No. 8 Main River Truss, Top Chord at U4, DS Truss

Condition: Up to 1" rust pack with $\frac{1}{4}$ " section loss to chord plate around the pin plate

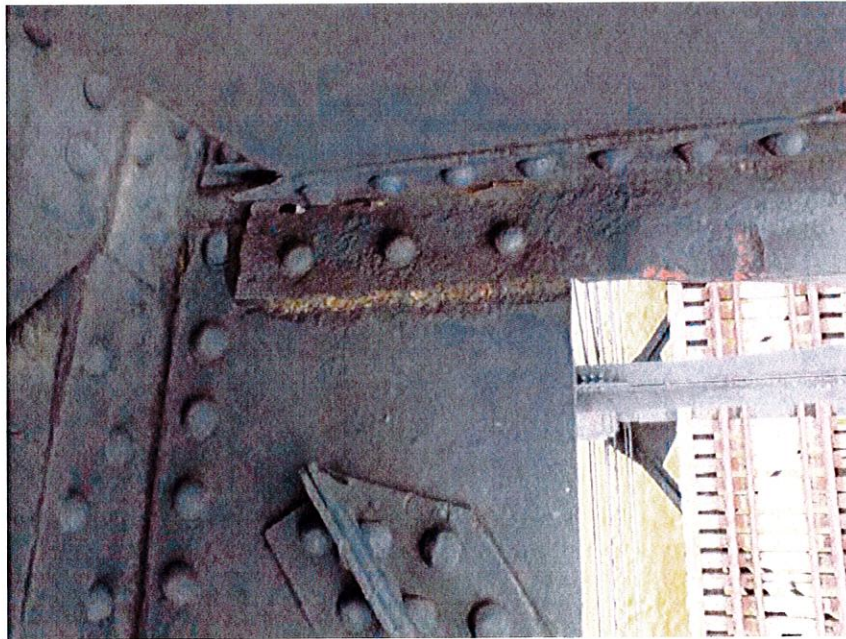
Photo No. 9 Main River Truss, Top Chord at U2', DS Truss

4. The top lateral bracing for the main river truss and the flanking trusses have up to 50% section loss with small through holes at the connection to the top chord. It is estimated that several of these deteriorated areas will have to be reinforced as part of the rehabilitation of the bridge (See Photo 9 and repair item 25 in the attached estimate).

Condition: Up to 50% Section Loss to the end of the top lateral and the gusset plate

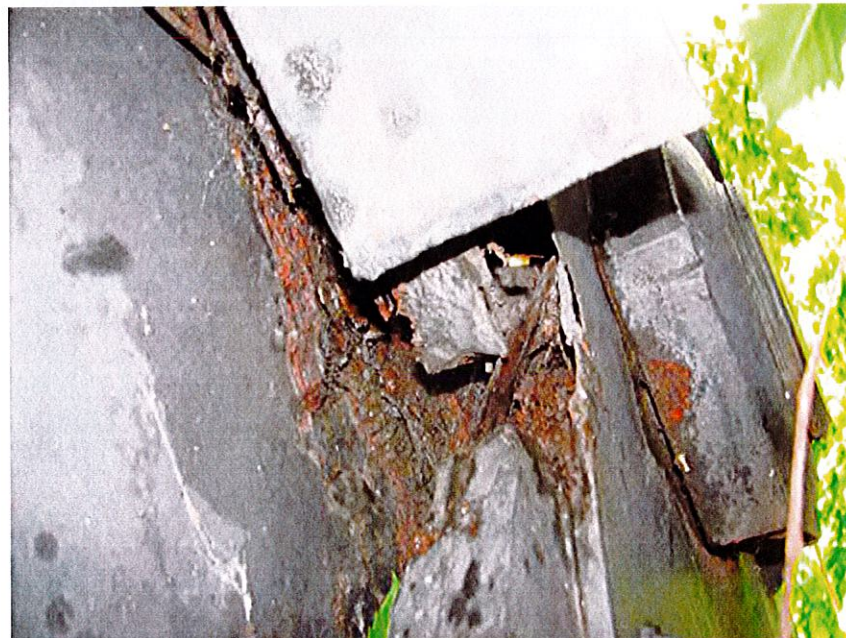
Photo No. 10 Pier 24, US Truss at L0

5. The bottom chord and diagonal at L0, Pier 24 for the flanking truss have significant section loss and should be strengthened (See Photo 10 and Item 26 in the estimate).

Condition: Web of diagonal is 50% gone around pin and bottom eyebars have 1" of 1-3/8" remaining

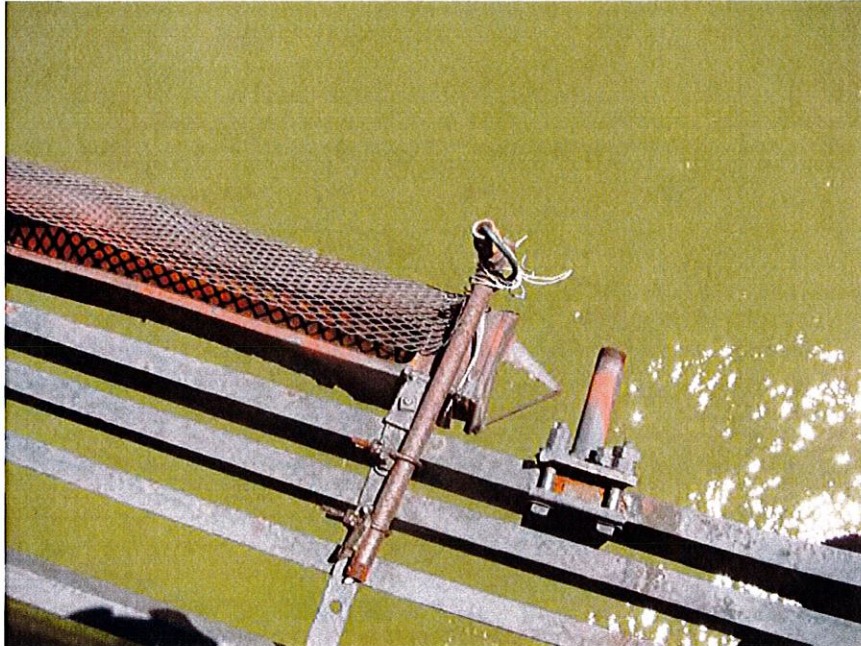
6. The navigational lights do not appear to be functional. The Coast Guard requires navigation lights over navigable rivers and clearance gauges on the main river piers (See Photos 11, 12 and Items 27 & 28 in the estimate).

Photo No. 11 Main River truss at mid-span, US truss
Condition: Missing navigation light

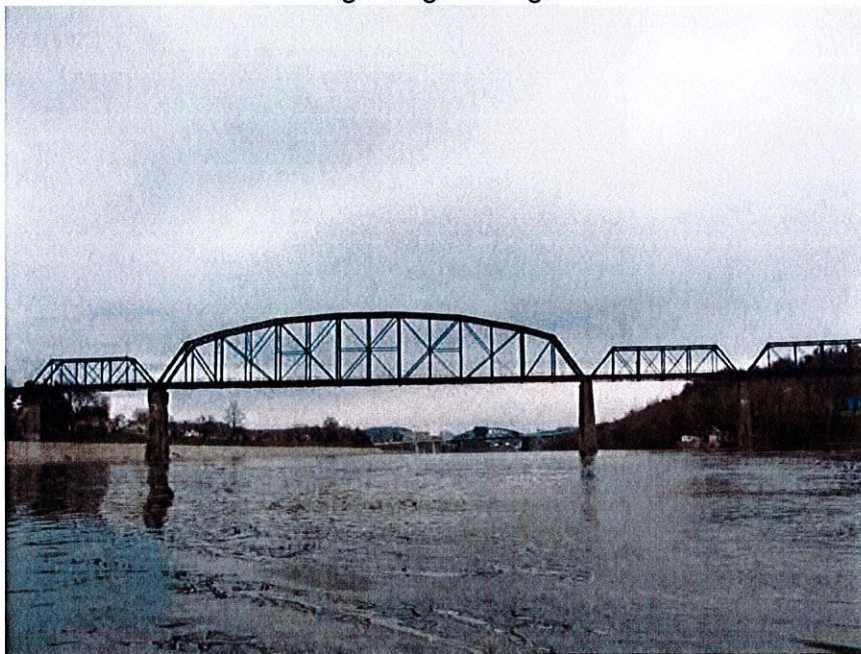
Photo No. 12 Main River truss, DS truss
Condition: Navigation Lights not working and no clearance gauges on piers

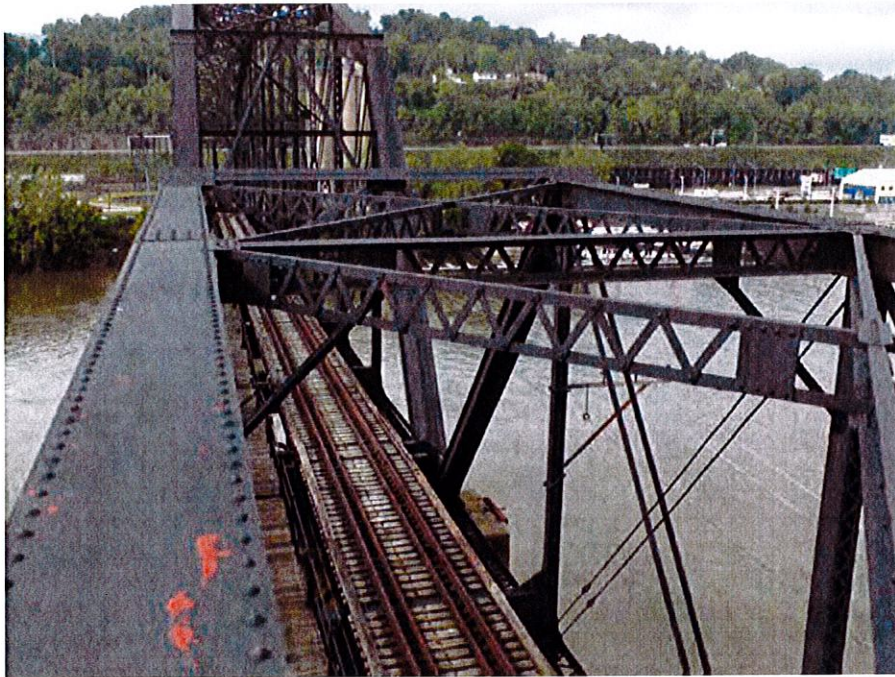
Photo No. 13 Top Chord, upstream truss between P 27 and P 28

Condition: Typical condition of the paint with possible red lead primer beneath

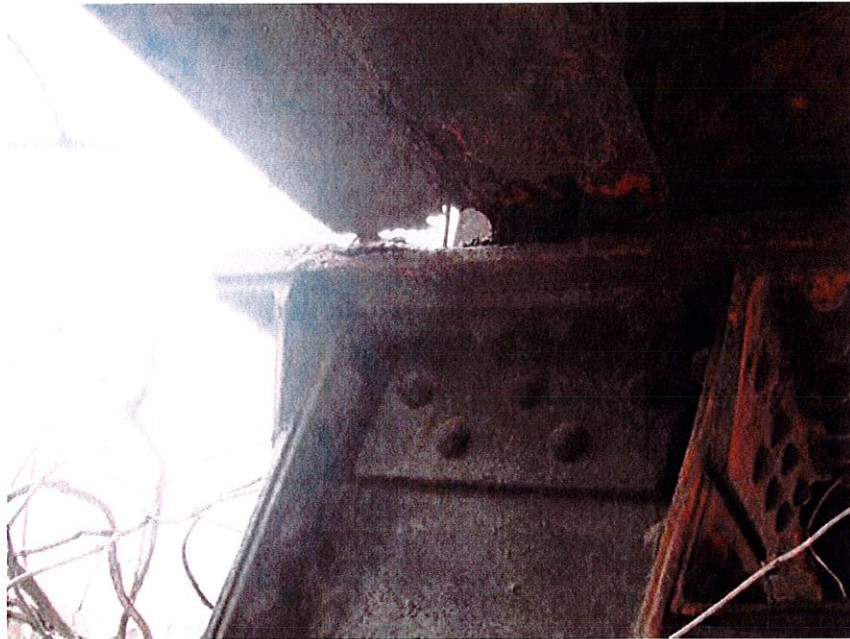
Photo No. 1 Girder 2 at Bent B45

1. The bottom flange at several bents has 50% to 100% section loss at the girder bearing area. This condition is fairly typical to both girders in the steel spans on the Charleston side to various degrees. (See Photos 1 to 3)

Condition: 100% section loss to the bottom flange angles

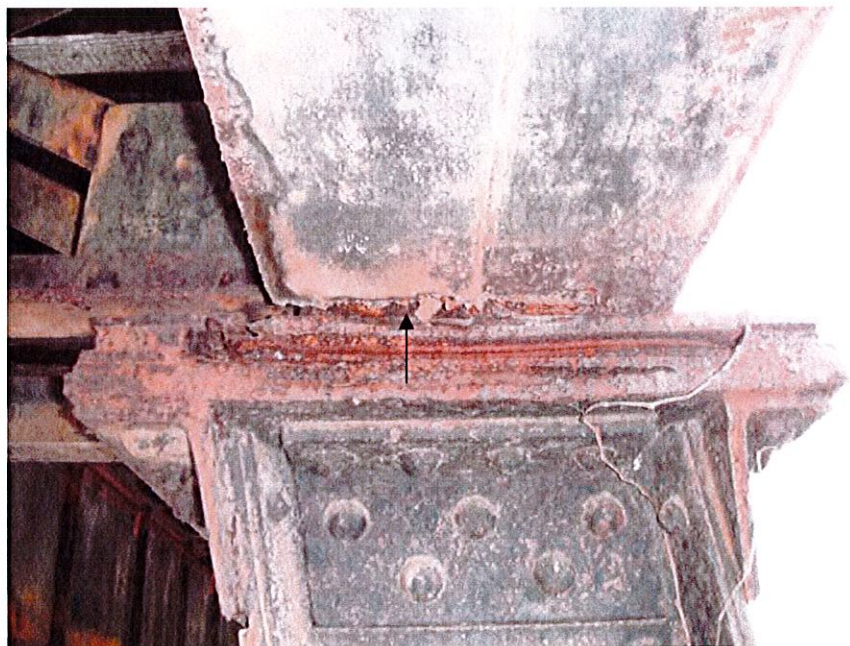
Photo No. 2 Girder 2 at Bent A1

Condition: 90% section loss to bottom flange (See Arrow)

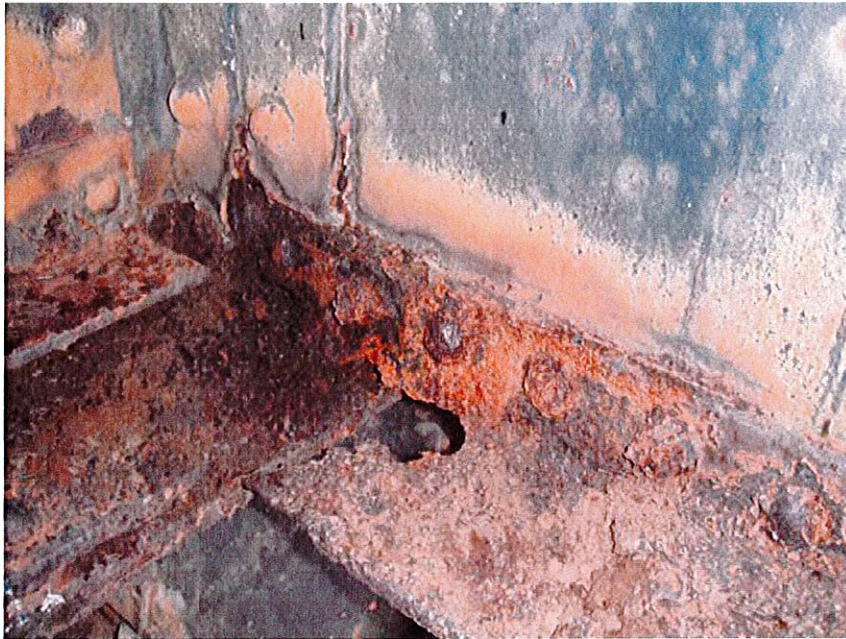
Photo No. 3 Girder 2 at Bent A2

Condition: 100% section loss to the inside bottom flange angle

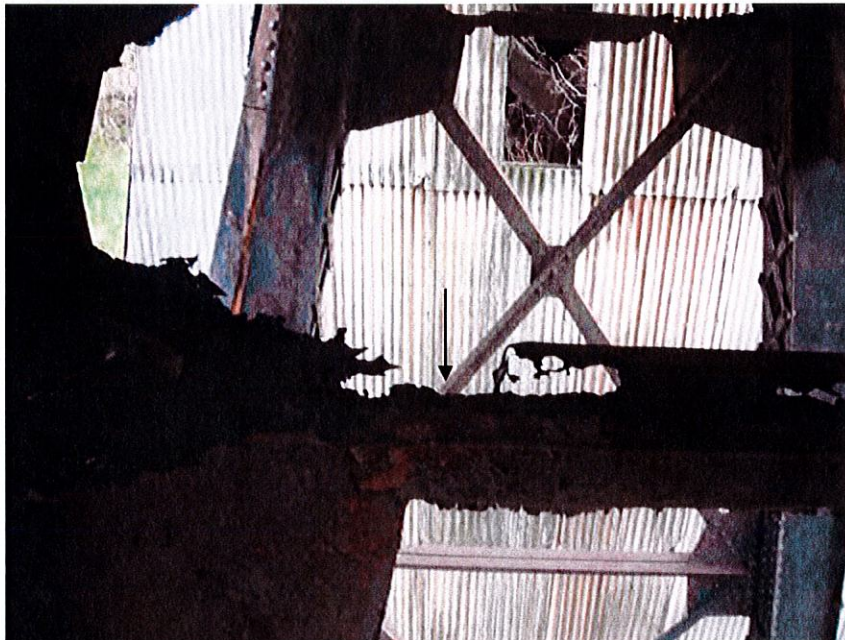
Photo No. 4 Span A5 – A6, Sway Bracing Angles

2. There is a 10 ft. span between bent A5 and A6 over the sidewalk adjacent to 2nd Ave. This span has numerous defects and could potentially be replaced. The bottom flange is deteriorated to the point that the girder is bearing on its web. The top flange has an area that exhibits 100% section loss to the interior angle leg. The cross frame angles have up to 50% section loss. (See Photos 4 to 6)

Condition: Sway Bracing has up to 50% section loss

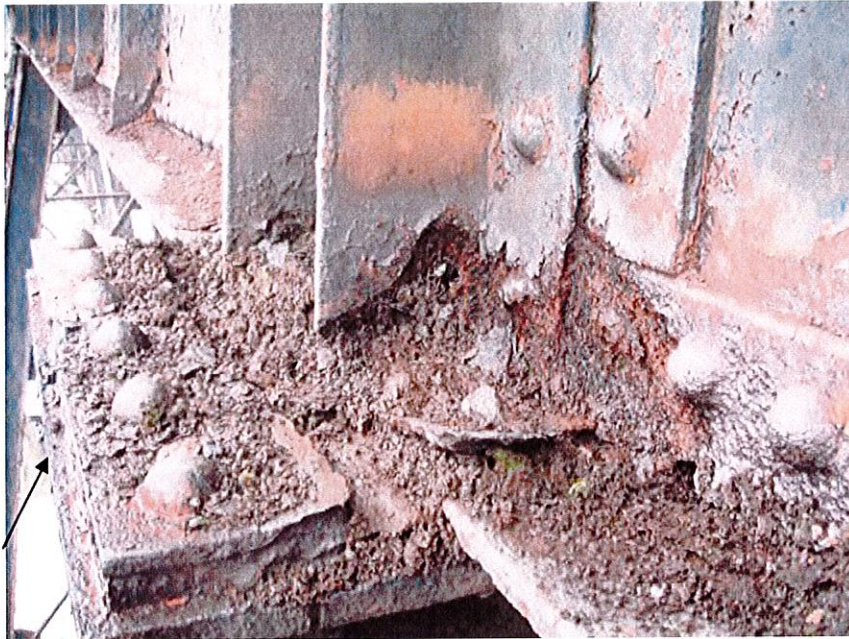
Photo No. 5 Girder 1 Bearing area at Bent A5

Condition: Girder bearing on its web due to flange deterioration

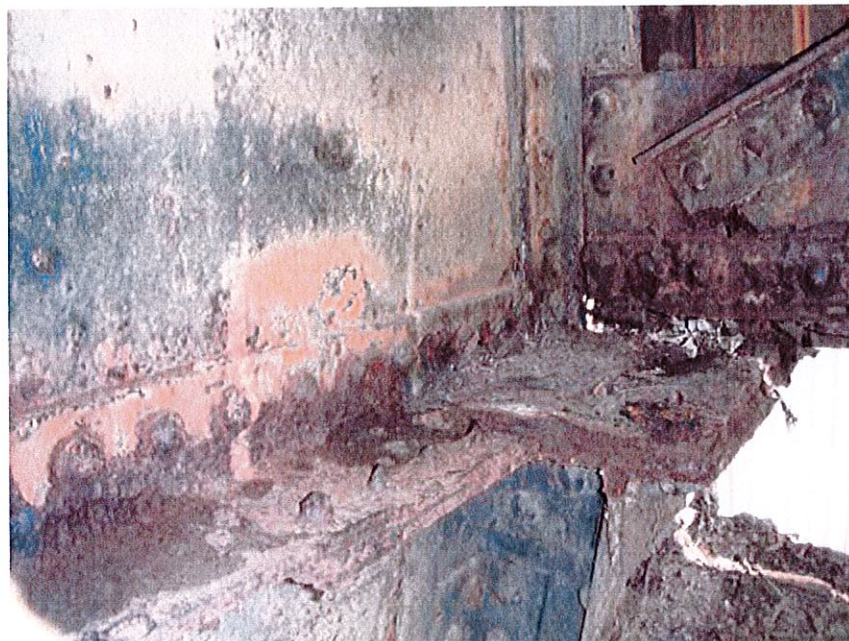
Photo No. 6 Girder 1 at Bent A6

Condition: Bottom flange deteriorated at X-bracing support

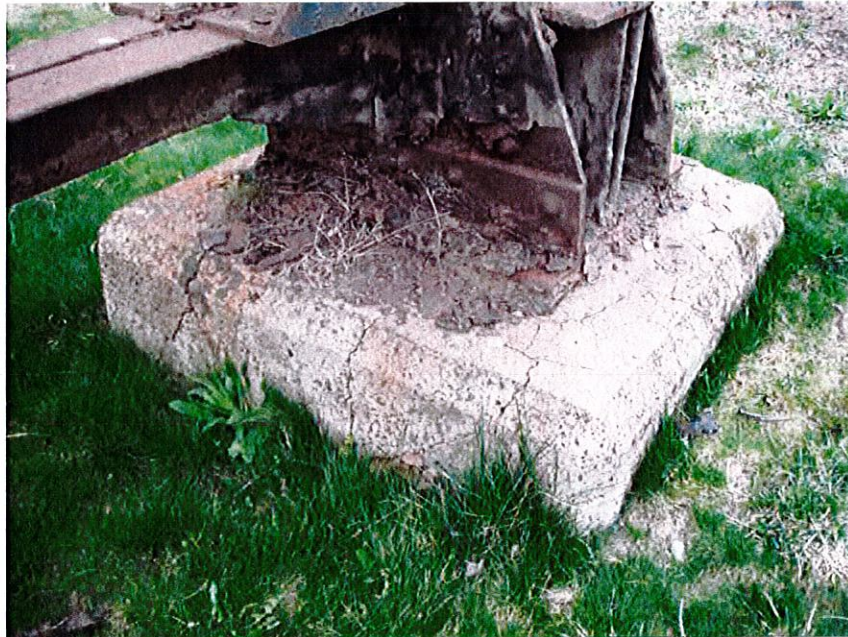
Photo No. 7 Bent B15 (other locations similar)

3. Several of the concrete pedestals that support the steel tower bents are in need of repairs. They typically exhibit map cracking with up to 1/8" wide open cracks as well as spalls and crumbling concrete. (See Photos 7 to 8)

Condition: Map cracking with 1/8" wide open cracks

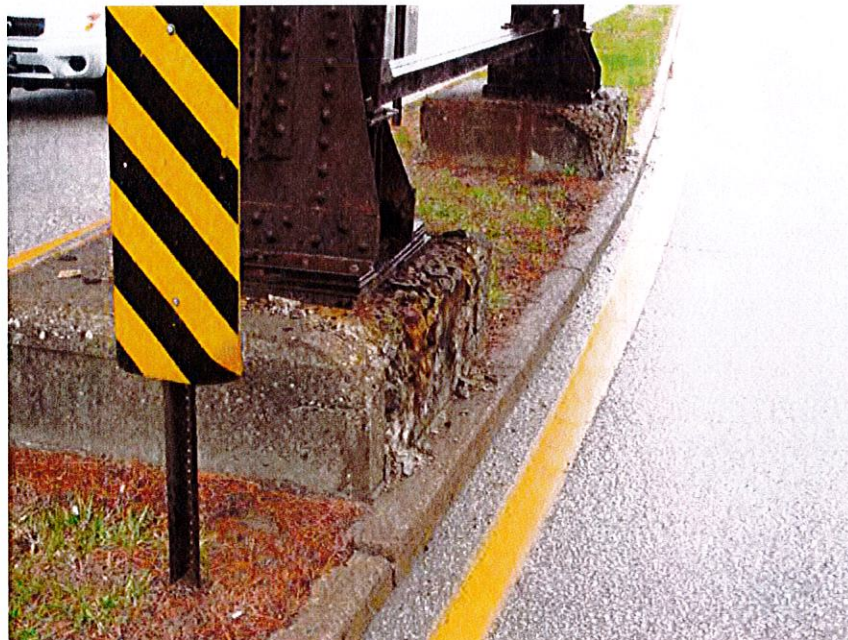
Photo No. 8 Bent B30 (Median of Kanawha Blvd.)

Condition: Up to 3" deep spall to pedestal

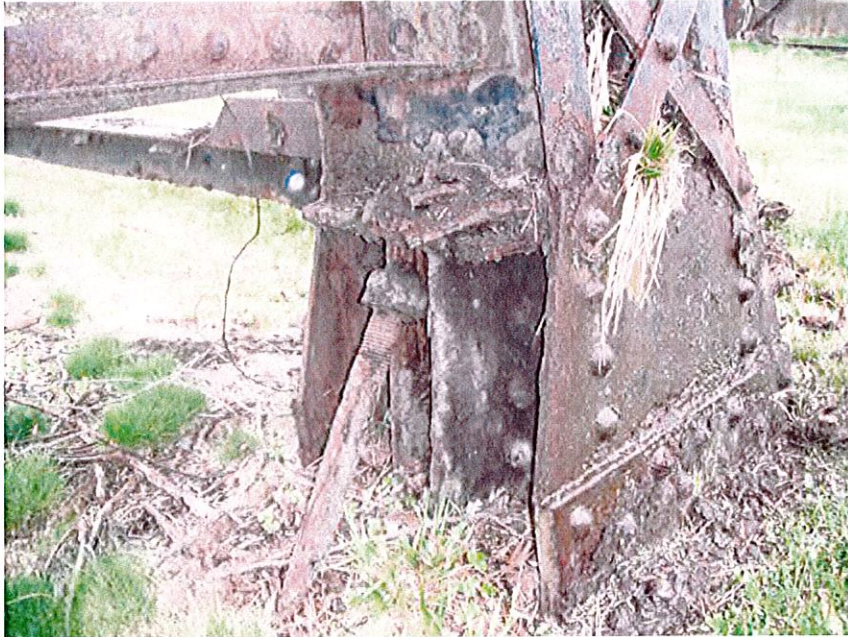
Photo No. 9 Bent B8 (South Charleston Side)

4. During the inspection there were several bent column base connections and anchor bolts that were in poor condition. Anchor bolts were found to be missing, broken and loose. The bent column base connection was typically found to be full of debris and exhibits heavy surface rust and section loss. (See Photos 9 to 10)

Condition: Broken anchor bolt

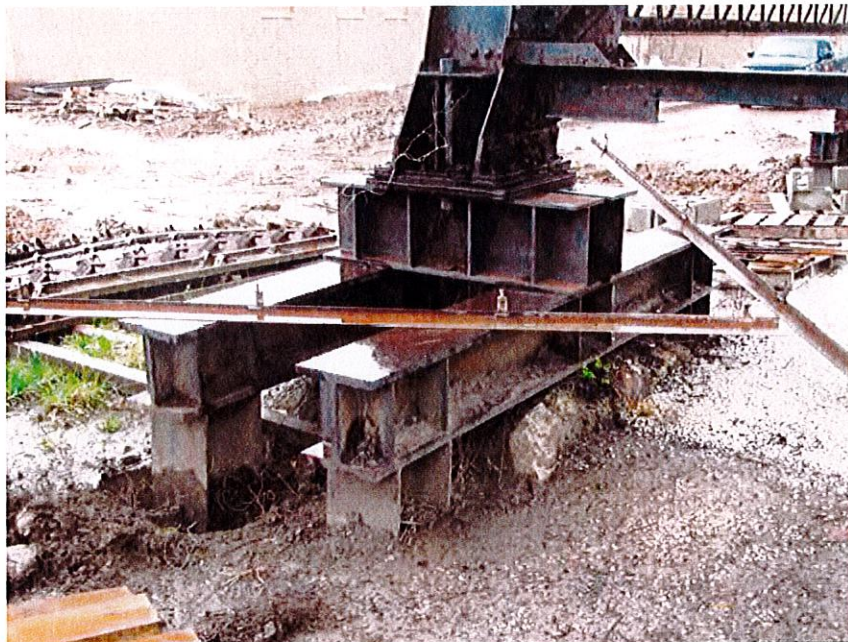
Photo No. 10 Temporary bent support at Bent B33

Condition: Repair bent column base connection, pedestal and anchor bolts

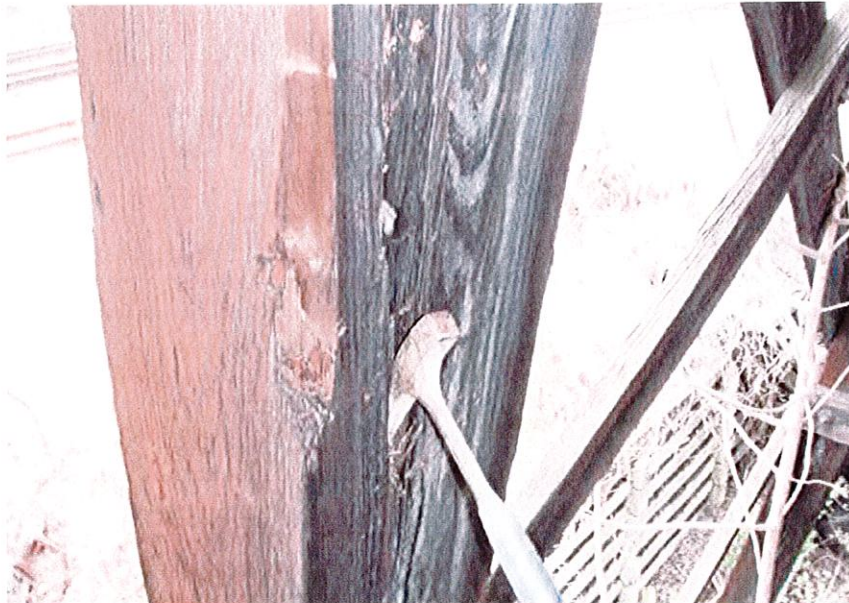
Photo No. 1 Timber Bent T73

Condition: Vertical Split in Post affecting 15% of pile area.

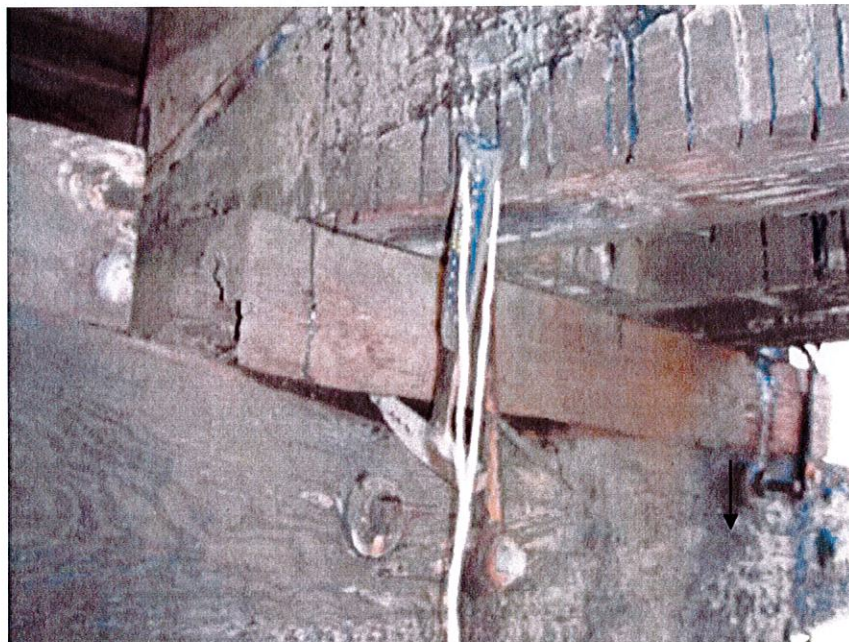
Photo No. 2 Timber Bent T72

4. The bearing shims on top of the bent caps are crushed or rotten in multiple locations (See Photos 2,3, & 6). These shims should be replaced and they are quantified in item #16 and item #50 on the cost estimate.

Condition: Shim block is 50% rotted, replace

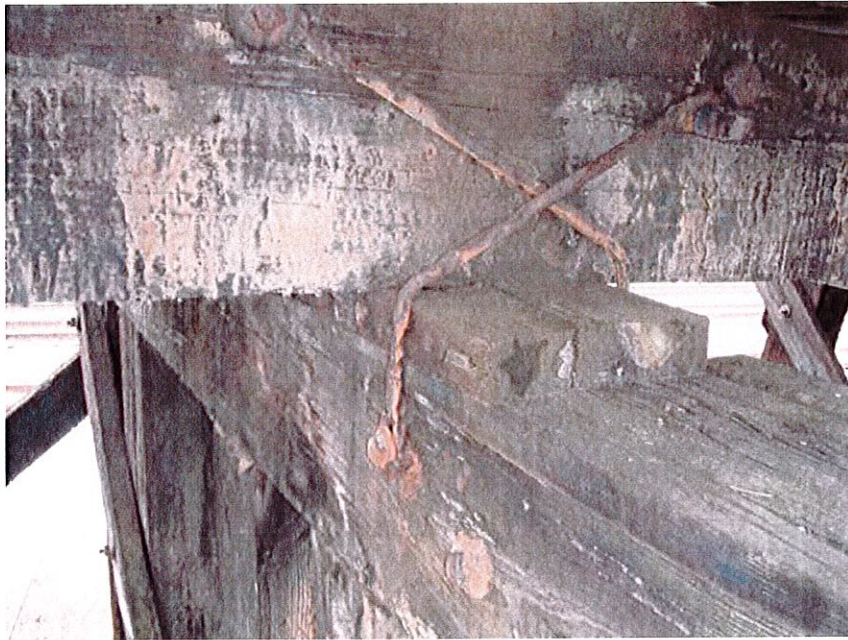
Photo No. 3 Timber Bent T72

Condition: Timber Shim is split and brooming.

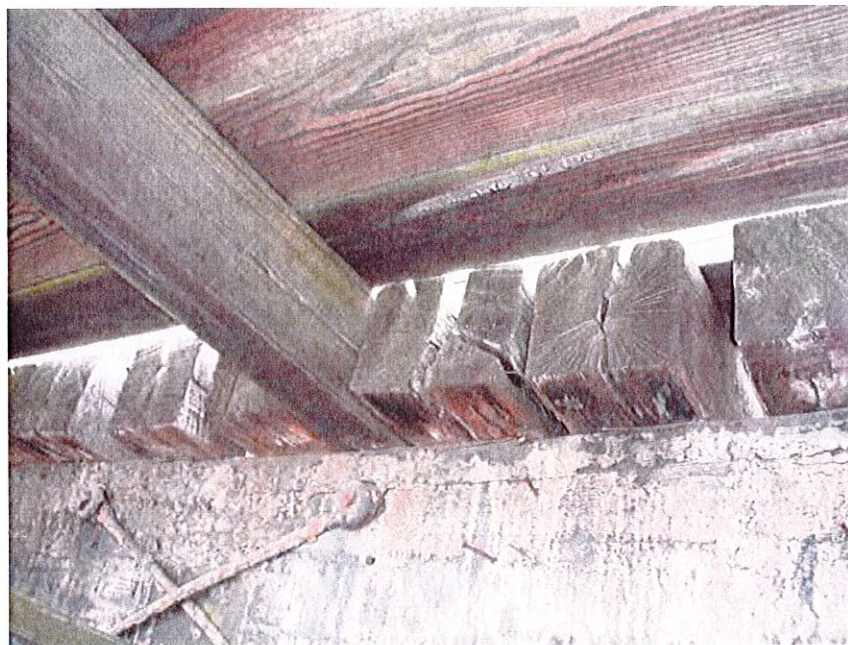
Photo No. 4 Deck ties along stringer 1.

Condition: Deck ties split at end, typical 50% of ties

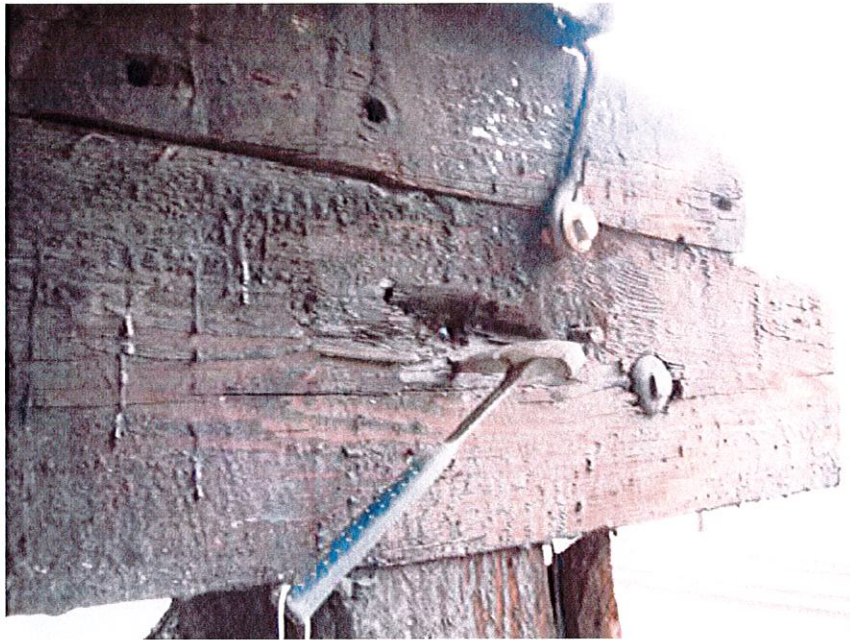
1. Timber bent caps at several locations show different degrees of decay. This condition is evident on both sides of the river (See Photo 5). This repair is quantified in item #15 and item #49 on the cost estimate.

Photo No. 5 Timber Bent T80
Condition: 35% of cap is decayed

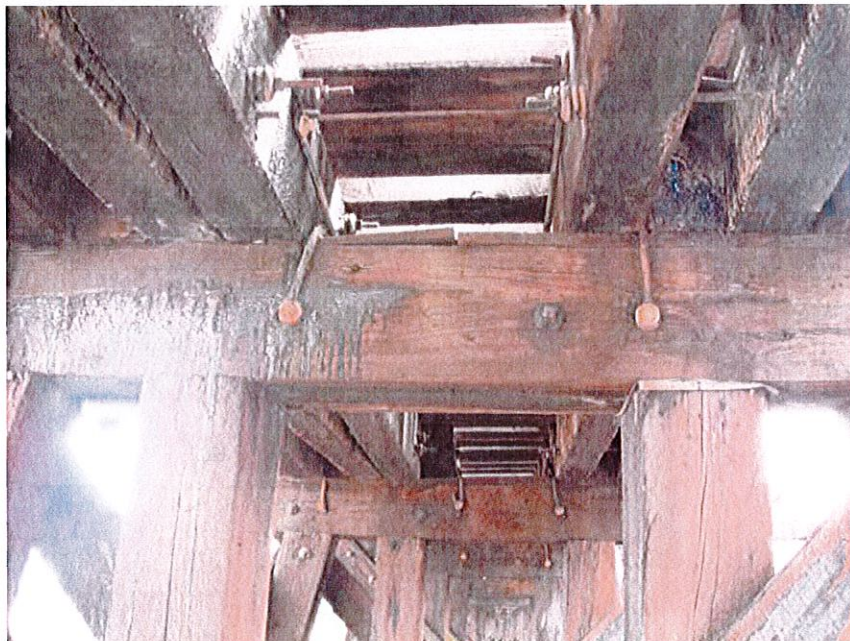
Photo No. 6 Timber Bent T81
Condition: Bearing shims are crushed

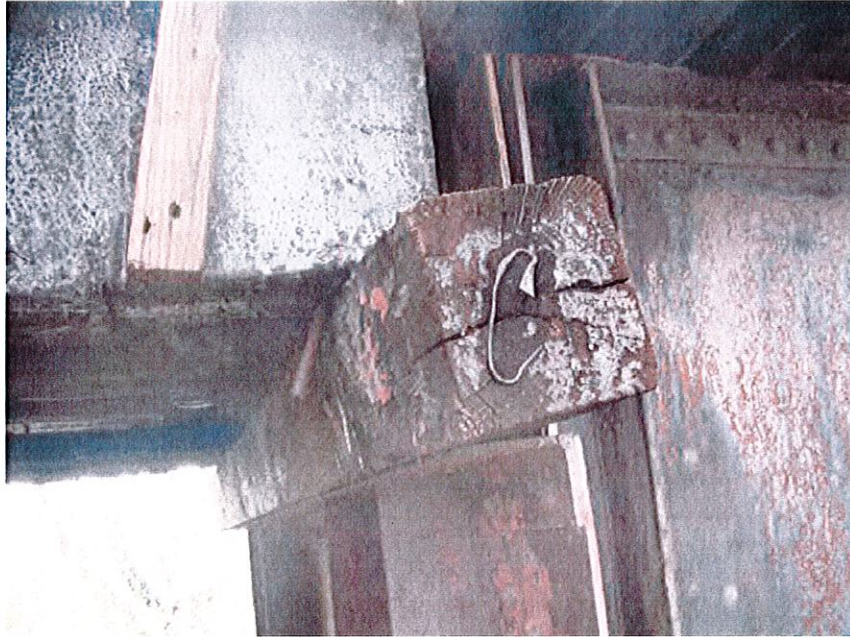
Photo No. 7 Timber Bent T84

Condition: Bent Cap is tilting, needs reset

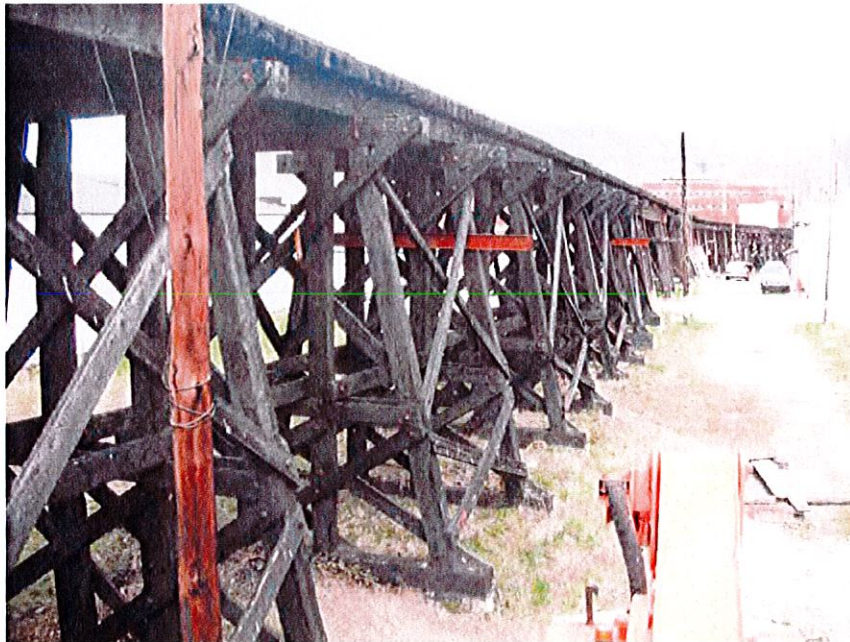
Photo No. 8 General View T112 – T121

6. On the Charleston side of the river, several timber bents and stringers were damaged due to fire (See Photo 8). This area should be coated with the possibility of some members that are excessively damaged to be replaced. This cost is included in item #45 on the cost estimate.

Condition: Fire Damage

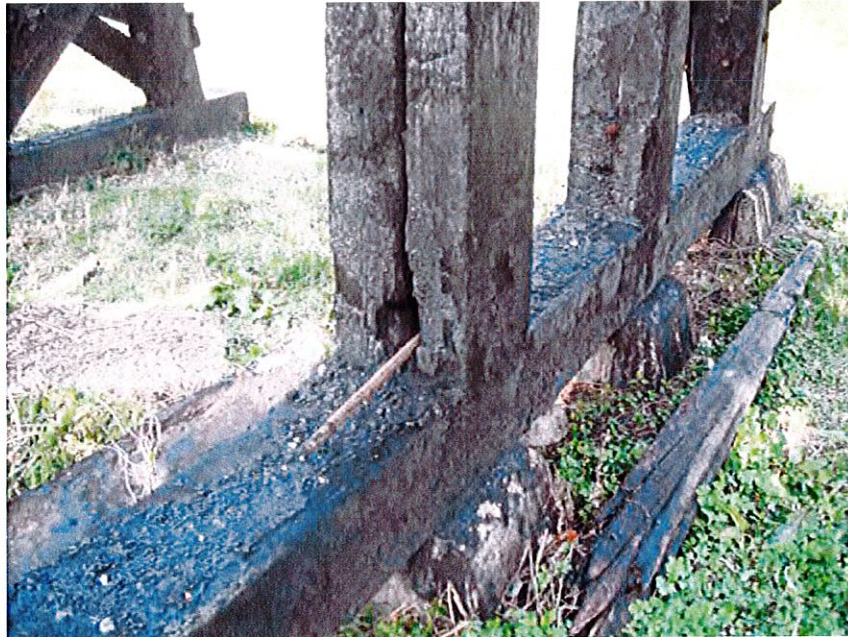
Photo No. 9 Timber Bent T120

Condition: 4" dia. Hole and full height split in post

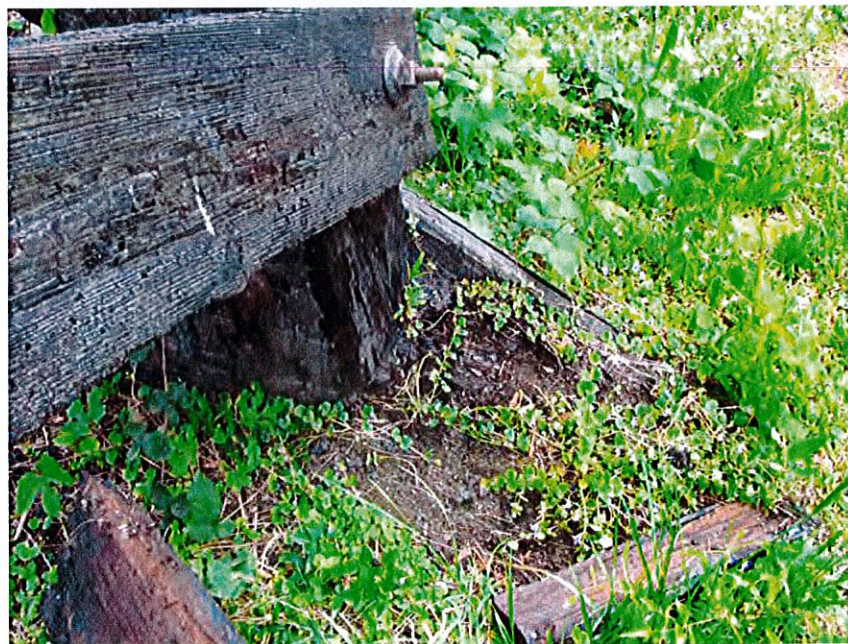
Photo No. 10 Timber Bent T114

3. The timber bent sills in select locations show large amounts of rot (See Photos 10 and 12). These sills need to be replaced and they are quantified in item #12 and item # 47 on the cost estimate.

Condition: Sill completely rotted, replace

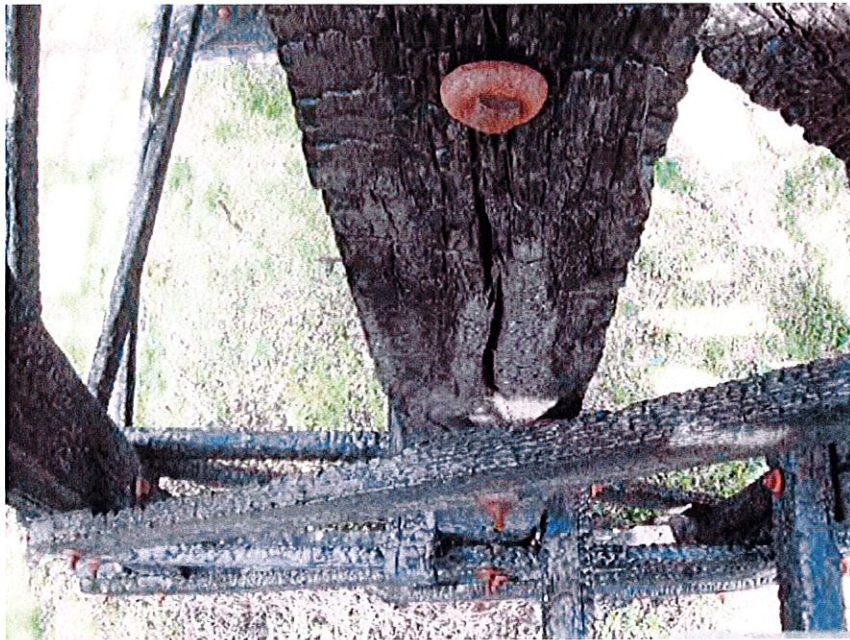
Photo No. 11 Timber Bent T116

5. Several timber posts are excessively split and their load carrying capacity is reduced (See Photo 11). These posts should be replaced and are quantified in item #51 on the cost estimate.

Condition: Post Split, full height

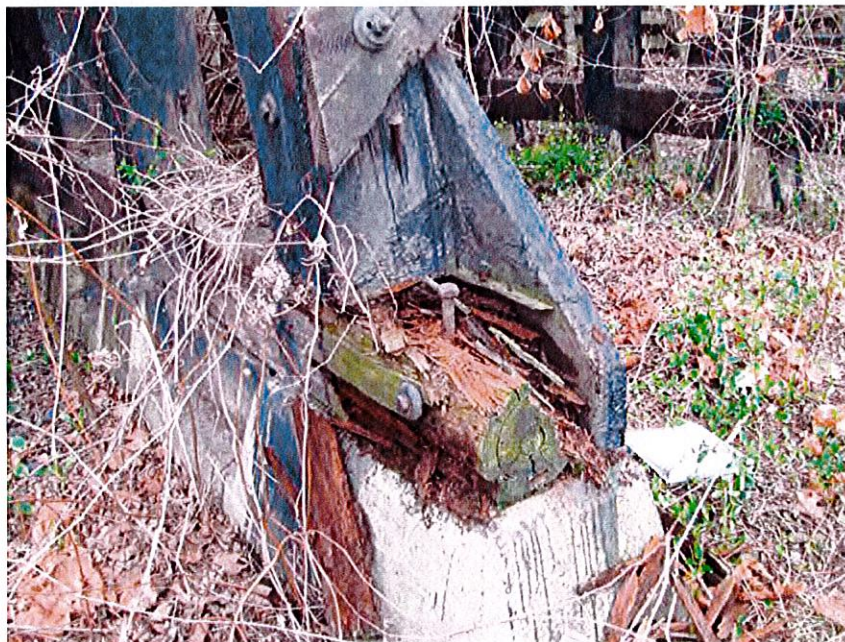
Photo No. 12 Timber Bent T35

Condition: End of Sill rotting, undermining support post

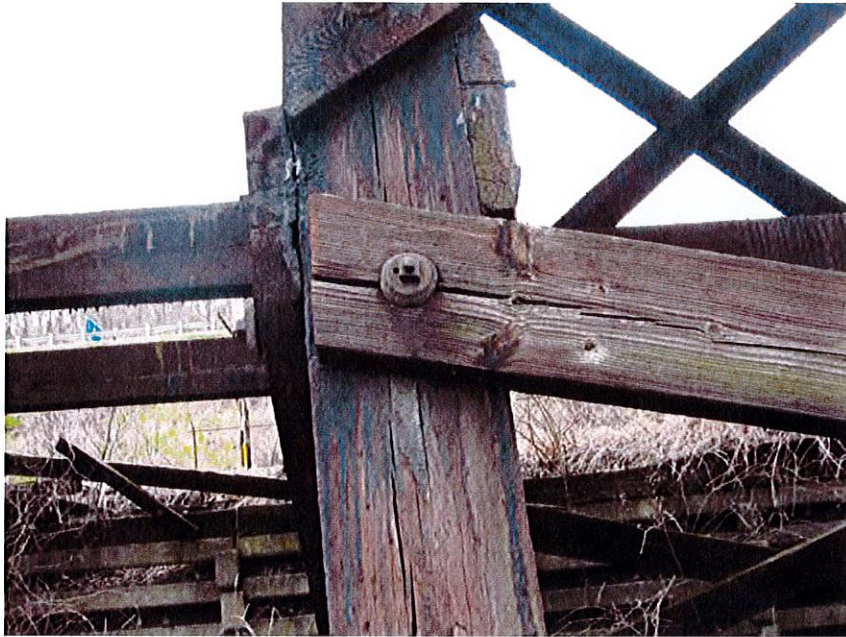
2. Several of the longitudinal and transverse bracings have fallen or are split and unable to transfer load (See Photo 13). These braces need to be replaced and is quantified in items #11, #13, #46, and #48 on the cost estimate.

Photo No. 13 Timber Tend T43
Condition: Typical Split in Diagonal Bracing

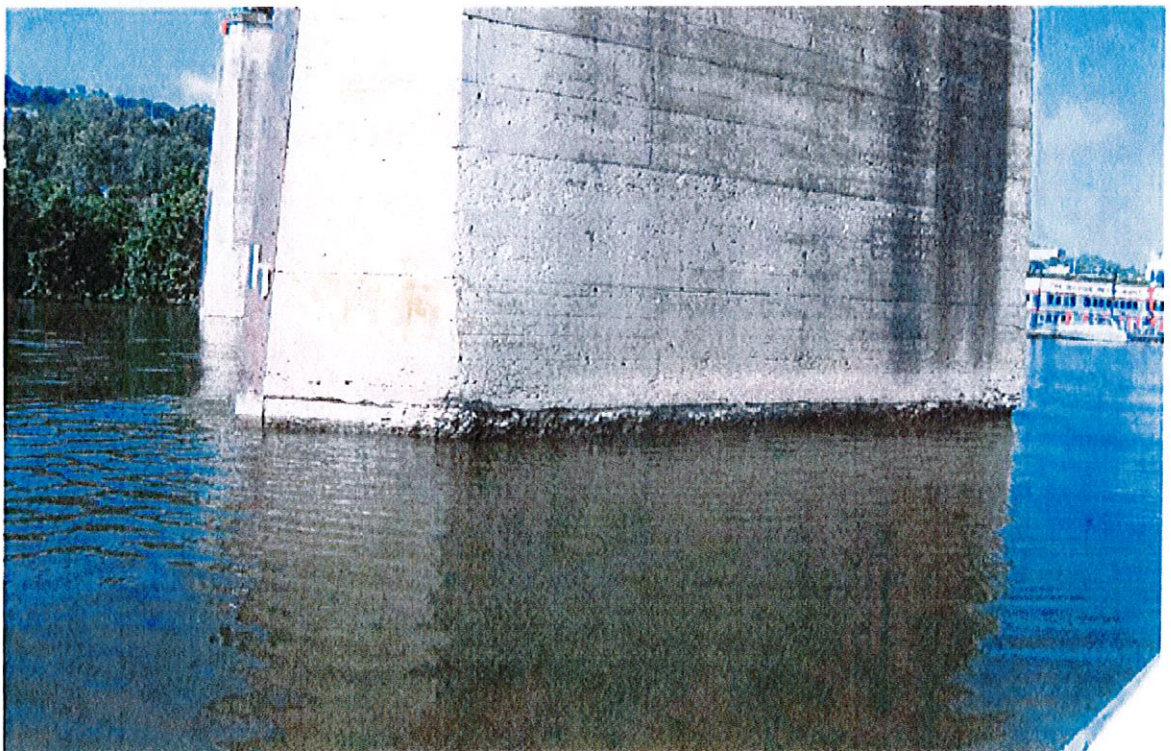
Figure 4. Severe concrete scaling at the waterline of Pier 3 (looking downstream)

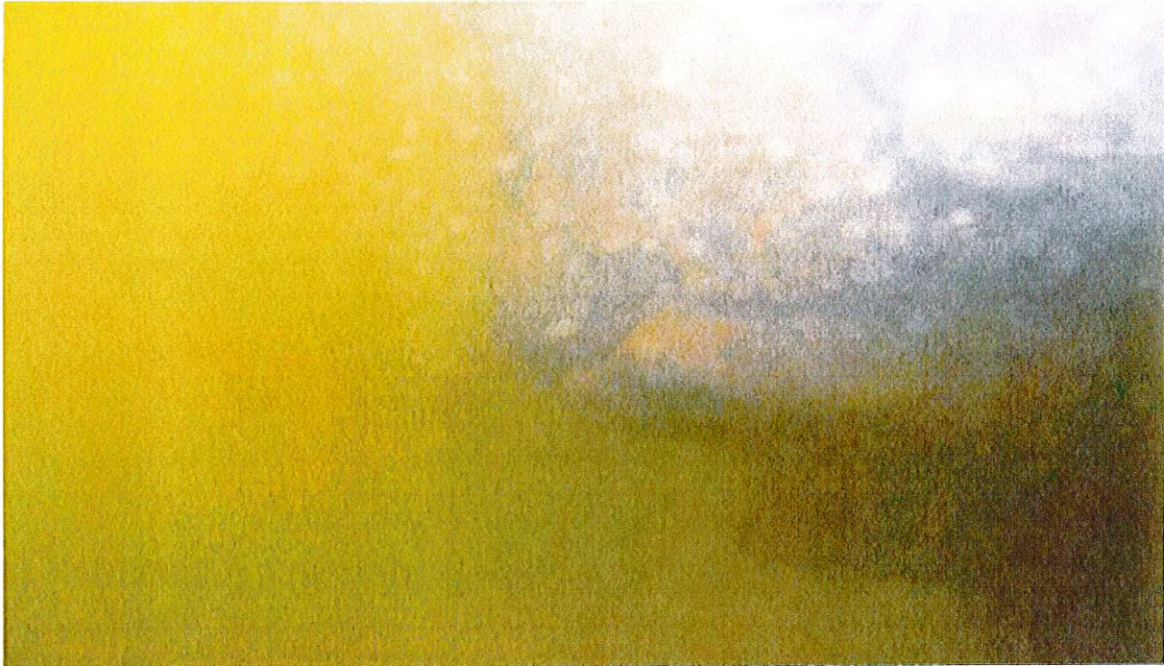
Figure 5. An area of eroded concrete on the corner of the downstream nose shore side of Pier 3
